ESL-TR-84-52

A Limited Test of Solvent Reclamation at an Air Force Flightline Facility

FINAL REPORT
APRIL 1985 - OCTOBER 1984

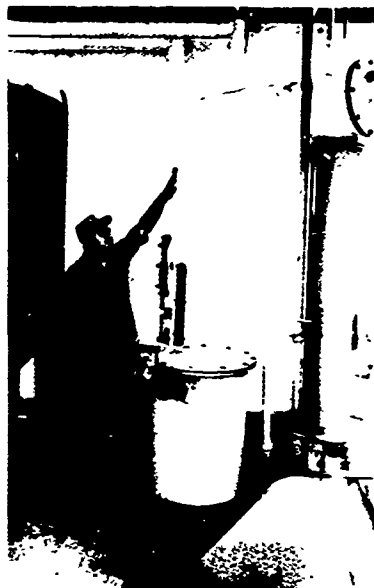
Figure 1. Solvent Reclamation Unit

The solvent reclamation unit was purchased as a complete system via a multisource procurement action to meet existing requirements at Tyndall AFB. The solvent reclamation unit (See Figure 1) was purchased from Gardner Machinery Corporation of Charlotte, North Carolina. The Unit consisted of a Western-Hilmor vacuum still, with an integrated Reimers Electra Steam boiler, a clarifier tank, and associated plumbing and control accessories. The physical layout and approximate dimensions are indicated in Figure 2.

1. Still. The Western-Hilmor 200 Industrial Still was rated for 200 to 225 gallons per hour solvent recovery from waste stock consisting of 10 to 25 percent oil and grease. The unit stands 86 inches high and requires 35 by 48 inches of floor area. Electric service requirements for the still were 480 volts, 16 amp, three-phase (Reference 3).

2. Boiler. A dedicated steam boiler, Reimers Electra Steam, Model RHP200, rated to 150 psi steam pressure required 45-foot separation for safety considerations. The unit stands 45 inches high, and requires 45 by 70 inches of floor area.
